# Availability of transmission capacity in the Nordics

Q4/2017

# Report description

This report provides aggregated information about available electricity transmission capacities between Nordic bidding zones and neighboring countries.

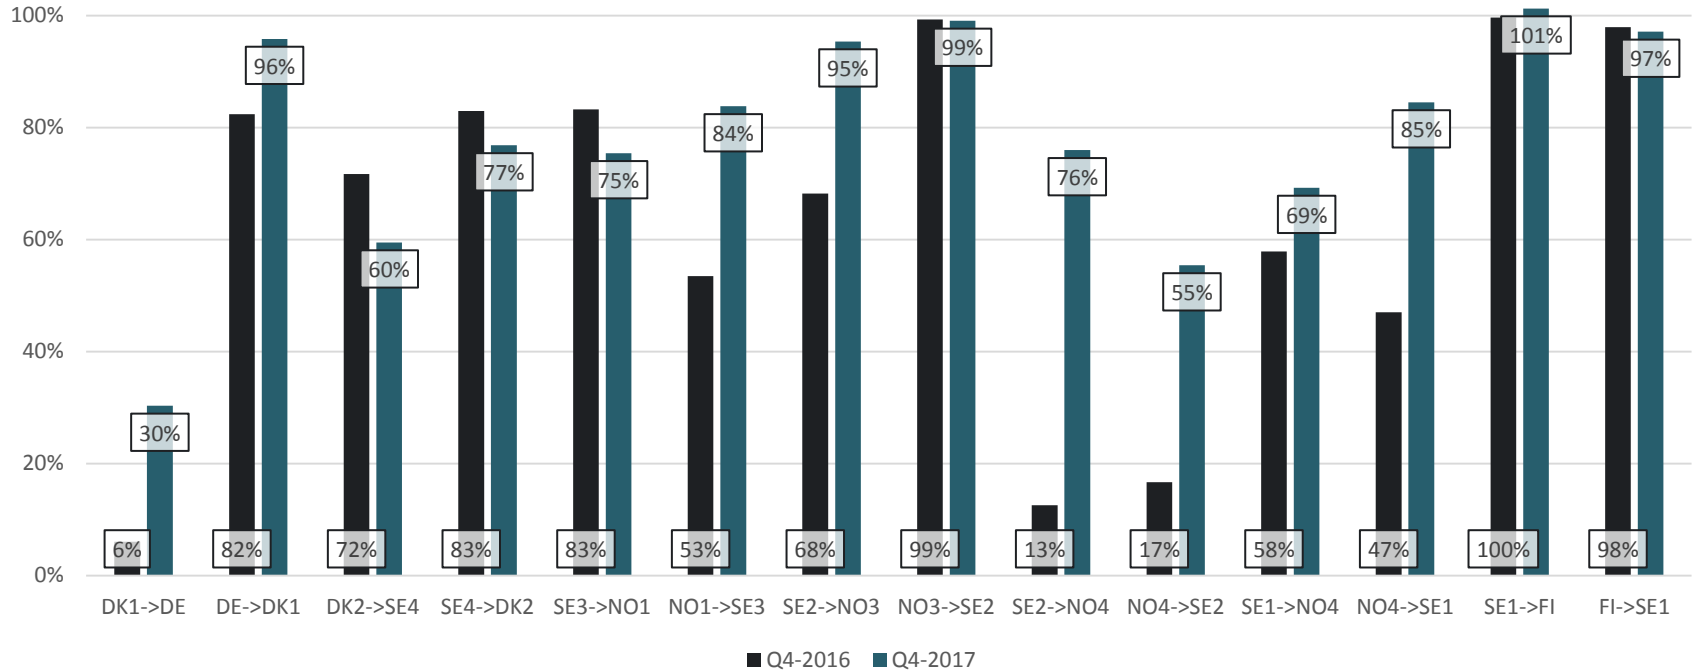
# AC-interconnectors - quarterly

The figures show the average share of available capacity on the day ahead market (ATC) to the maximum capacity (max NTC) on each border and direction.

- **NO4-SE1 (North Norway-Sweden)**
  - The main reason for the reduction of capacity between Norway (NO4) to Sweden (SE1) was outages in the Norwegian grid due to voltage upgrades.

- **NO4-SE2 (North Norway-Sweden)**
  - The main reason for the reduction of capacity between Norway (NO4) and Sweden (SE2) was outages in the Norwegian grid due to voltage upgrades.

- **NO1-SE3 (Southern Norway-Sweden)**
  - The main reason for reduction of capacity from Norway (NO1) to Sweden (SE3) was cable fault on 420 kV Sylling-Tegneby.
